**BUILDING
MATERIALS
AND
STRUCTURES**
REPORT BMS39

Structural Properties of a Wall
Construction of "Pfeifer Units"

Sponsored by the
Wisconsin Units Company

REPORT BMS39

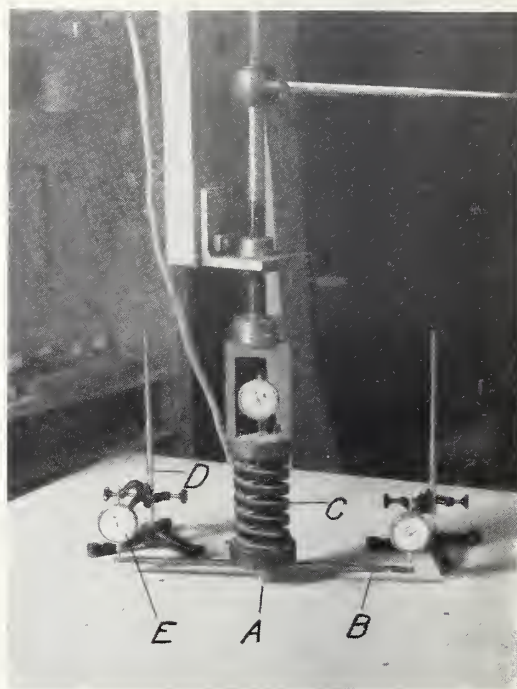
FIGURE 1.—*Apparatus for concentrated load test.*
A, steel disk; B, crossbar; C, dynamometer; D, stand; E, dial micrometer.

The indentation under concentrated load and the set after the load was removed were measured, not the set only, as described in BMS2. The apparatus is shown in figure 1. The load was applied to a steel disk, A, to which the crossbar, B, was rigidly attached. The load was measured by means of the dynamometer, C. There were two stands, D, resting on the face of the specimen, and each sup-

ported a dial micrometer, E' , the spindle of which was in contact with the crossbar 8 in. from the disk. The micrometers were graduated to 0.001 in., and the readings were recorded to the nearest division. The initial reading (average of the micrometer readings) was observed under the initial load, which included the weight of the disk and dynamometer. A load was applied to the disk, and the depth of the indentation under load was taken as the average of the micrometer readings minus the initial reading. The load was then removed, and the set was taken as the average of the micrometer readings minus the initial reading.

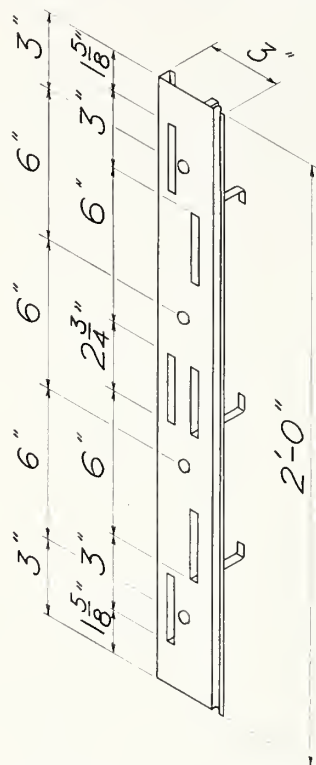
FIGURE 2.—Sheet-steel binder.

hearth, SAE 1010 sheet steel, No. 20 U. S. Std. Gage (0.037 in. thick), formed as shown in figures 2 and 3. The chemical composition of the sheet steel is given in table 4. Each binder was plated with cadmium, the thickness of the coat ranging from 0.0008 to 0.0010 in. The manufacturer was the Milwaukee Stamping Co.

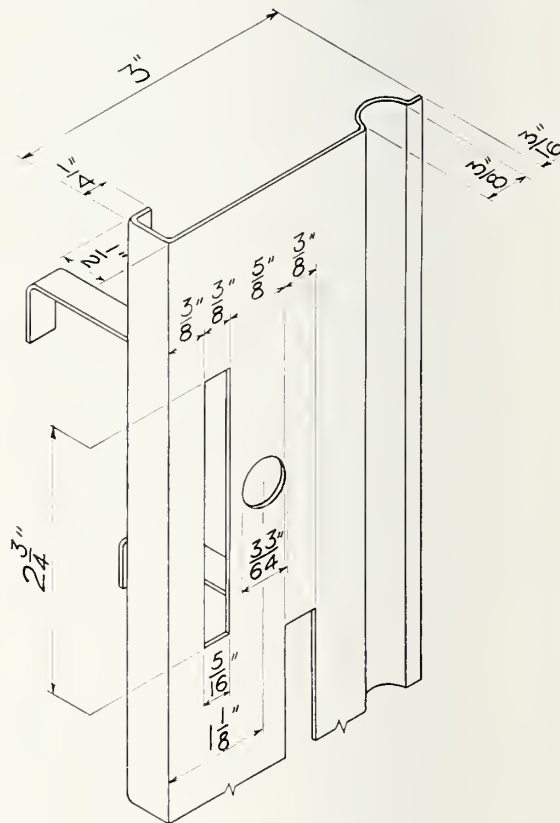
FIGURE 3.—Details of binder.

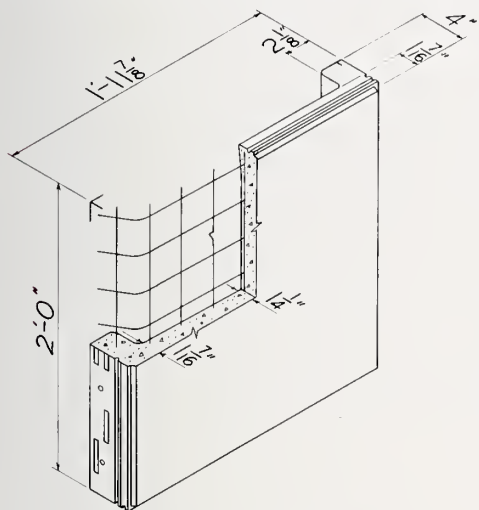
FIGURE 4.—Concrete unit.

The units, shown in figure 4, were 2 ft 0 in. high, 1 ft 11 $\frac{7}{8}$ in. wide, and 1 $\frac{1}{4}$ in. thick at midwidth. There was a flange, in which a sheet-steel binder was embedded, along each longitudinal edge. There were four holes, $\frac{5}{16}$ -

in. diam, in each flange 2 $\frac{7}{8}$ in. from the outside face of the unit and spaced 6 in. on centers. Along each edge of the unit were semicircular grooves, $\frac{3}{8}$ -in. diam. The distance from the outside face of the unit to the outer edges of the grooves was $\frac{1}{16}$ in. The outside face of the unit was rabbeted $\frac{1}{4}$ in. along each of the four edges.

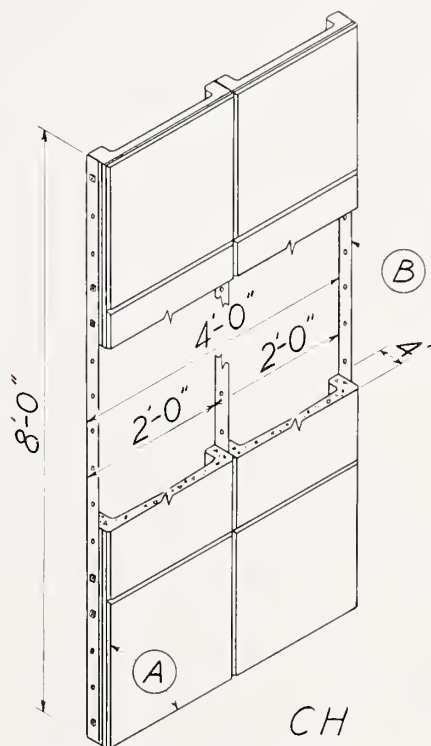
FIGURE 5.—Four-foot wall specimen CH.

A, concrete unit; B, bonding plate.

(1) *Four-foot wall specimens.*—The 4-ft specimens, shown in figure 5, were 8 ft 0 in. high, 4 ft 0 in. wide, and 4 in. thick at the ribs. Each specimen consisted of eight concrete

units, *A*, and three bonding plates, *B*. There were two units in each course and a bonding plate on each longitudinal (vertical) edge and one in the joint at midwidth. The units and bonding plates were fastened by bolts through the holes in the flanges and the plates. There were eight $2\frac{3}{4}$ -in. bolts along each longitudinal edge and eight $5\frac{1}{2}$ -in. bolts along the joint at midwidth. The bolts were in the top and bottom holes in each unit. There were two washers on each bolt, one under the head and the other under the nut. Each nut was tightened until the torque was about 11 lb-ft.

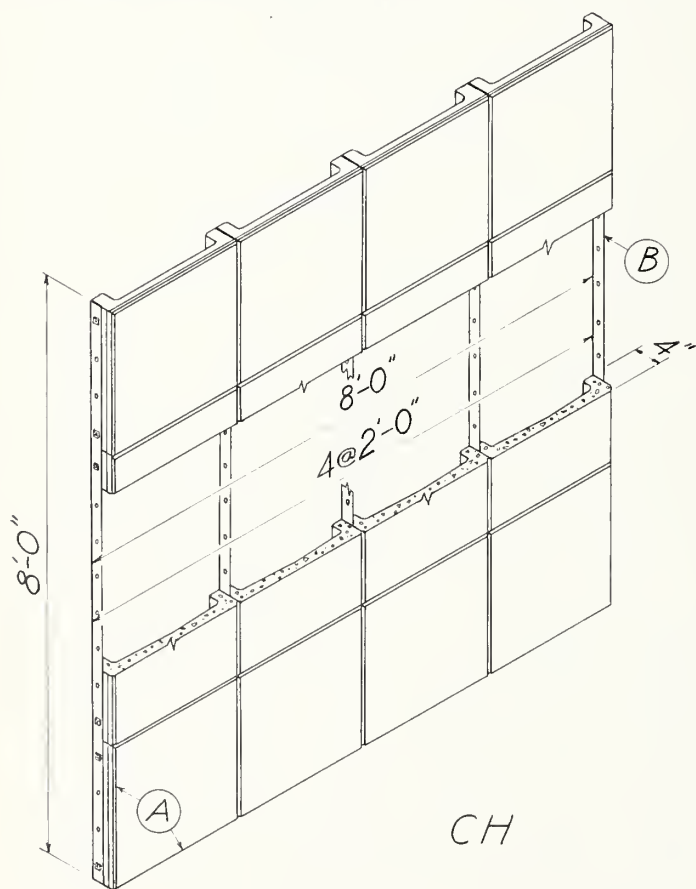
FIGURE 6.—Eight-foot wall specimen CH.
A, concrete unit; B, bonding plate.

(2) *Eight-foot wall specimens*.—The 8-ft specimens, shown in figure 6, were 8 ft 0 in. high, 8 ft 0 in. wide, and 4 in. thick. The construc-

tion was similar to the 4-ft specimens except that there were four units in each course and five bonding plates.

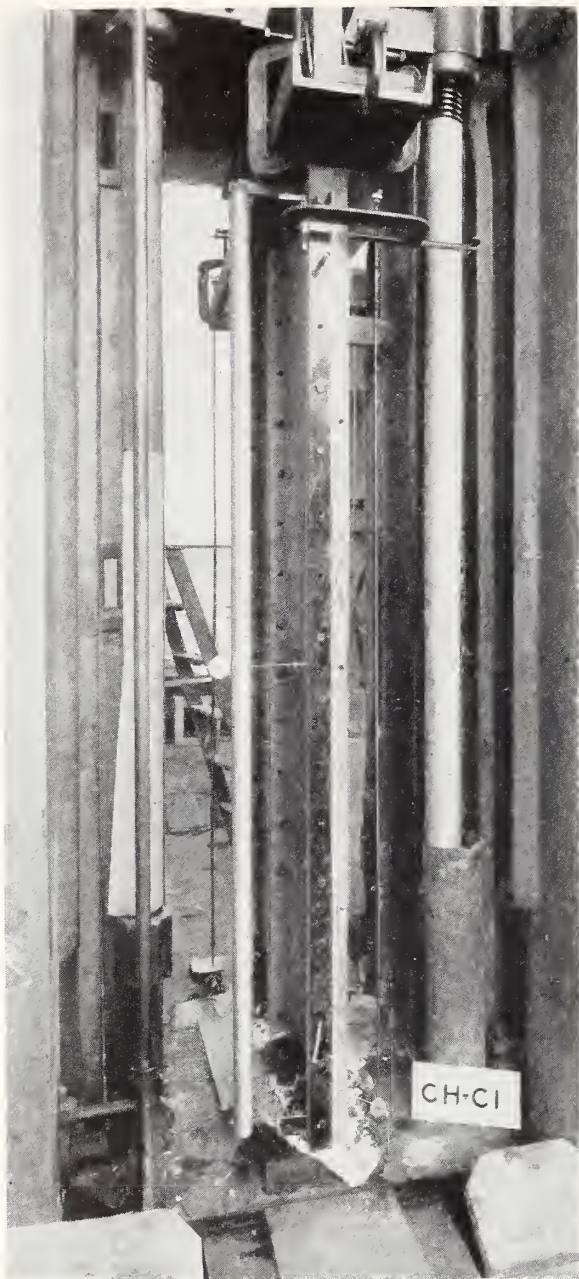
FIGURE 7.—Wall specimen CH-C1 under compressive load.

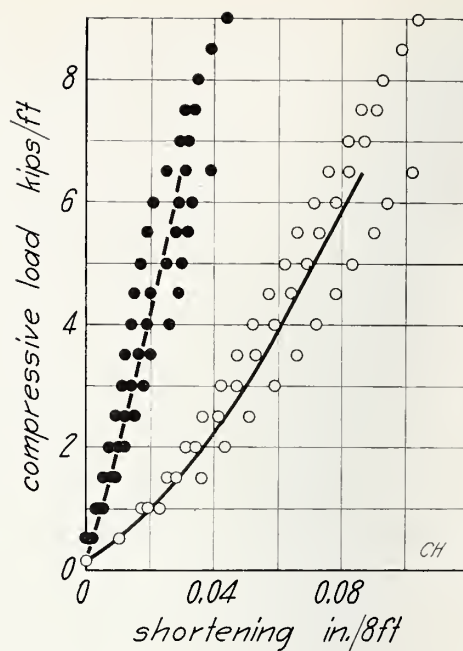
FIGURE 8.—Compressive load on wall CH.

Load-shortening (open circles) and load-set (solid circles) results for specimens CH-C1, C2, and C3. Load applied 1.33 in. (one-third the thickness) from the inside surface of the ribs. The loads are in kips per foot of actual width of specimen.

The shortenings and sets shown in figure 8 for a height of 8 ft were computed from the values obtained from the compressometer readings. The gage length of the compressometers was 8 ft $\frac{1}{2}$ in.

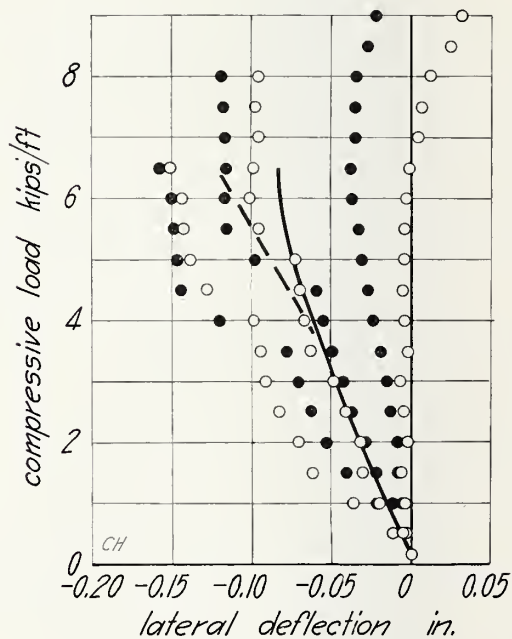
FIGURE 9.—Compressive load on wall CH.

Load-lateral deflection (open circles) and load-lateral set (solid circles) results for specimens CH-C1, C2, and C3. Load applied 1.33 in. (one-third the thickness) from the inside surface of the ribs. The loads are in kips per foot of actual width of specimen. The deflections and sets are for a gage length of 7 ft 6 in., the gage length of the deflectometers.

The lateral deflections shown in figure 9 were plotted to the right of the vertical axis for deflections of the specimen toward the outside

Under loads less than 7 kips/ft on specimen *C3* the deflections were small and the sets were numerically greater. Under greater loads this specimen deflected increasingly toward the out-

side face, but the sets (toward the inside face) were nearly constant. Because the thickness of the bonding plates was small (0.077 in), they probably did not have a pronounced effect on the compressive properties of the specimens, but functioned principally to join and align the concrete units. Inspection of the specimens before they were tested showed that at the horizontal joints the units were in contact only at the flanges (which faced toward the inside of the wall). As regards the lateral deflections and sets under compressive loads, these specimens did not behave like elastic engineering structures, and no reasonable explanation for their behavior was found.

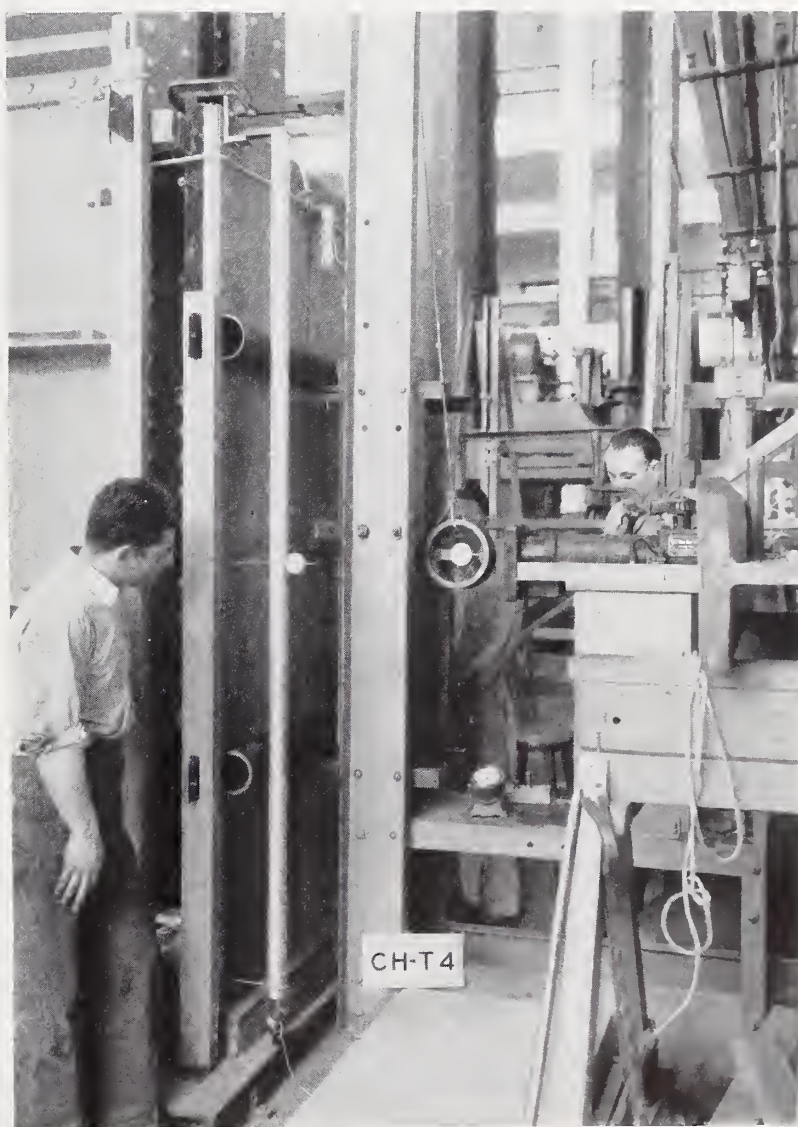
FIGURE 10.—Wall specimen *CH-T4* under transverse load.

Wall specimen *CH-T4* under transverse load is shown in figure 10. The results are shown in table 5 and in figure 11 for wall specimens *CH-T1*, *T2*, and *T3*, loaded on the inside face, and in figure 12 for wall specimens *CH-T4*, *T5*, and *T6*, loaded on the outside face.

The transverse load was applied to specimen *T1* in a horizontal position. The load due to the weight of the loading apparatus and the specimen was 23.3 lb/ft², and the deflection caused by this load was 0.77 in. The results for specimen *T1* are shown in figure 11 for loads of 25, 30, 35, and 40 lb/ft². The transverse loads were applied to specimens *T2*, *T3*, *T4*, *T5*, and *T6* in a vertical position, as shown in figure 10; hence there was neither initial load nor deflection.

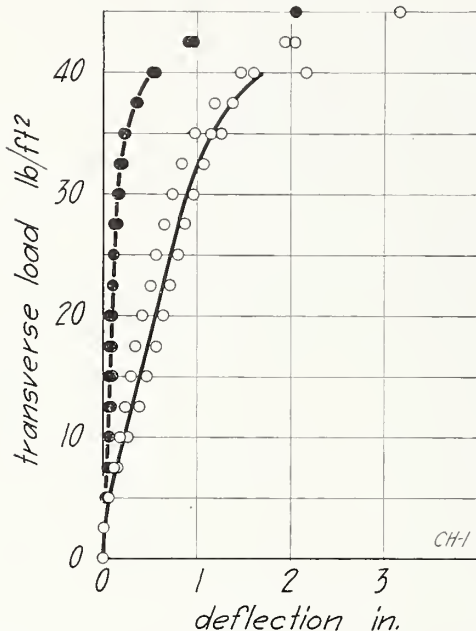
FIGURE 11.—Transverse load on wall *CH*, load applied to inside face.

Load-deflection (open circles) and load-set (solid circles) results for specimens *CH-T1*, *T2*, and *T3* on the span 7 ft 6 in.

Under a load of 35 lb/ft² on specimen *T1*, the bonding plates at the longitudinal edges buckled at midspan, and under a load of 40 lb/ft² the edges of the flanges of the units crushed along the joint at midspan. Under a load of 32.5 lb/ft² on specimen *T2*, one unit cracked along the base of the flange at midwidth, and under a load of 45 lb/ft² one outer bonding plate

buckled noticeably. Under the maximum load on each of the specimens *T1*, *T2*, and *T3*, the flanges of the units at midspan crushed and the bonding plates on the longitudinal edges buckled. The deflection increased without an increase in the load.

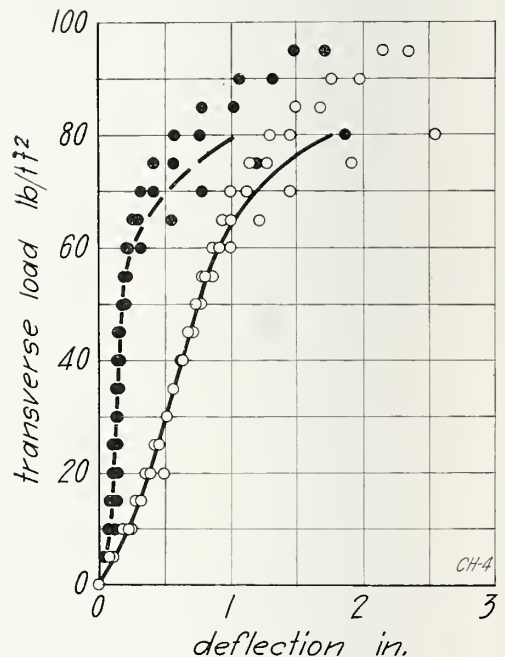
FIGURE 12.—Transverse load on wall *CH*, load applied to outside face.

Load-deflection (open circles) and load-set (solid circles) results for specimens *CH-T4*, *T5*, and *T6* on the span 7 ft 6 in.

Under a load of 70 lb/ft² on specimen *T4* and of 65 lb/ft² on specimen *T6* (applied to the outside face) the edges of one unit crushed. Under the maximum load on each of specimens *T4*, *T5*, and *T6*, the units crushed along the transverse joints and the deflection increased continuously without an increase in the load.

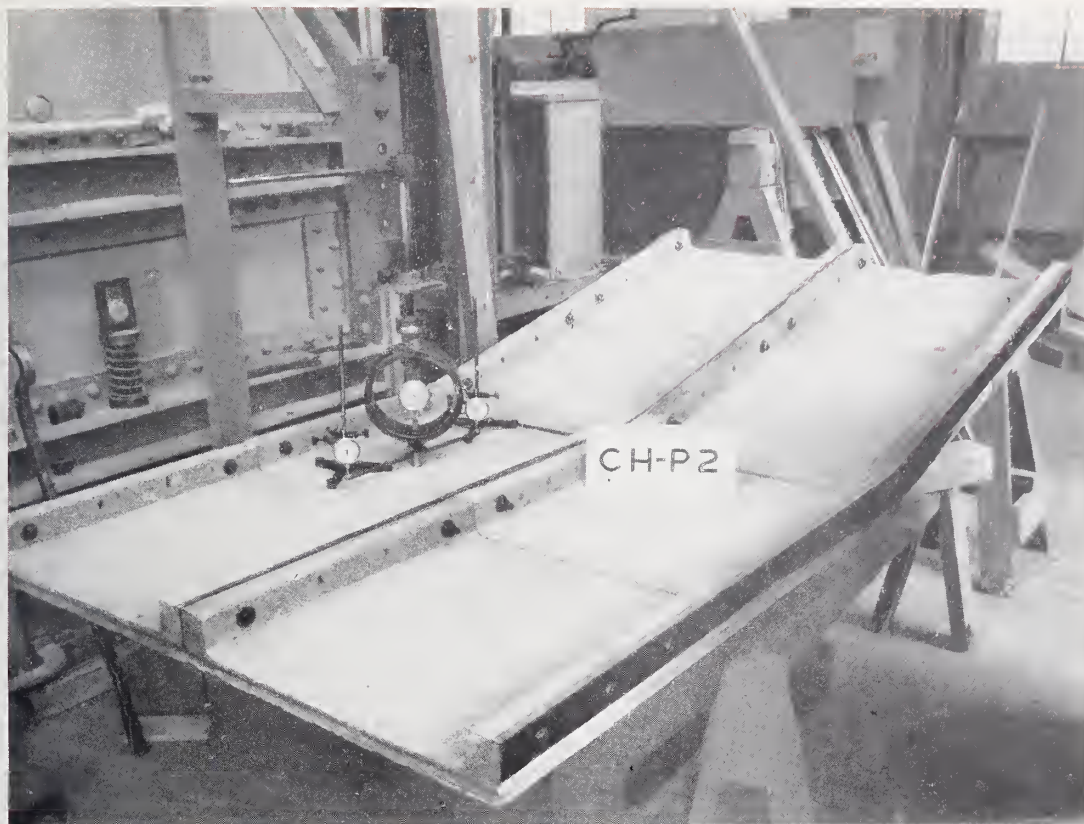
FIGURE 13.—Wall specimen CH-P2 under concentrated load.

Wall specimen *CH-P2* under concentrated load is shown in figure 13. The results are shown in table 5 and in figure 14 for wall specimens *CH-P1*, *P2*, and *P3*, loaded on the inside face, and in figure 15 for wall specimens *CH-P4*, *P5*, and *P6*, loaded on the outside face.

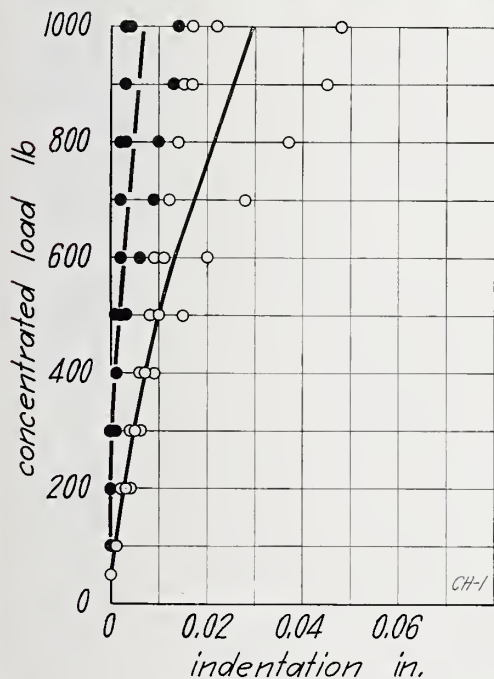
FIGURE 14.—Concentrated load on wall CH, load applied to inside face.

Load-indentation (open circles) and load-set (solid circles) results for specimens CH-P1, P2, and P3.

The concentrated loads were applied to the inside face of specimens *P1*, *P2*, and *P3* between the flanges of a unit, the outside (flat) face resting on a steel plate. After a load of 1,000 lb had been applied, the set in speci-

men *P1* was 0.003 in., in specimen *P2*, 0.014 in., and in specimen *P3*, 0.004 in., and no other effect was observed.

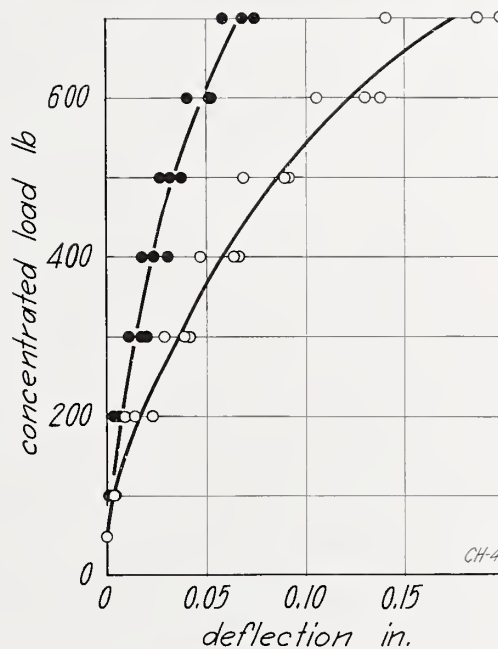
FIGURE 15.—Concentrated load on wall CH, load applied to outside face.

Load-indentation (open circles) and load-set (solid circles) results for specimens CH-P4, P5, and P6.

The concentrated loads were applied to the outside faces of specimens *P4*, *P5*, and *P6* between the flanges of a unit, the ribs of the inside face resting on a steel plate. After a load of 600 lb had been applied to each specimen, a longitudinal crack (parallel to the flanges) was visible in the inside face of the units. Under the maximum load, specimen *P4* failed by widening of this crack and specimens *P5* and *P6* by punching of the disk through the unit. The deformations were greater than those for the inside face, because they included the deflections of the web of the unit under the transverse load.

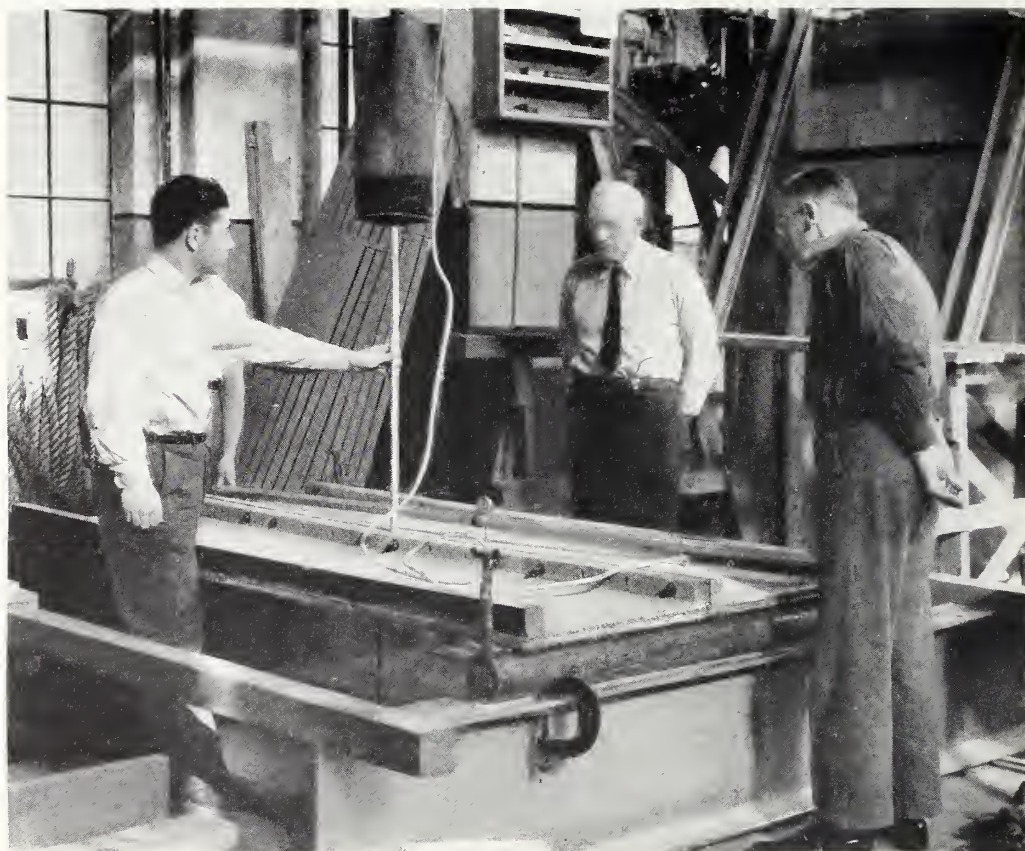
FIGURE 16.—Wall specimen *CH-13* during the impact test.

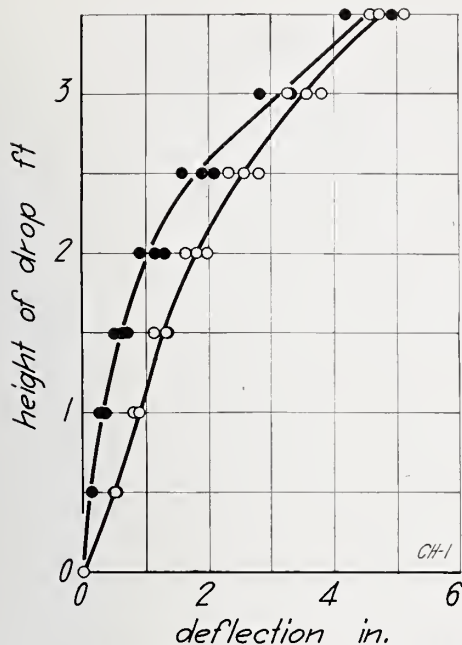
FIGURE 17.—Impact load on wall CH, load applied to inside face.

Height of drop-deflection (open circles) and height of drop set (solid circles) results for specimens CH-11, 12, and 13 on the span 7 ft 6 in.

Description of effects	Height of drop for specimens		
	<i>11</i>	<i>12</i>	<i>13</i>
First cracks in concrete at base of ribs of either one or two units near midspan.....	ft 2.5	ft 1.5	ft 1.5
Failure of specimen by opening of the transverse joint at midspan.....	2.5	1.5	2.0
Noticeable buckling of either one or two outer bonding plates.....	3.0	3.0	2.5
Maximum height of drop; under load, specimen came in contact with floor; deflection about 2 ft.....	5.5	5.5	5.5

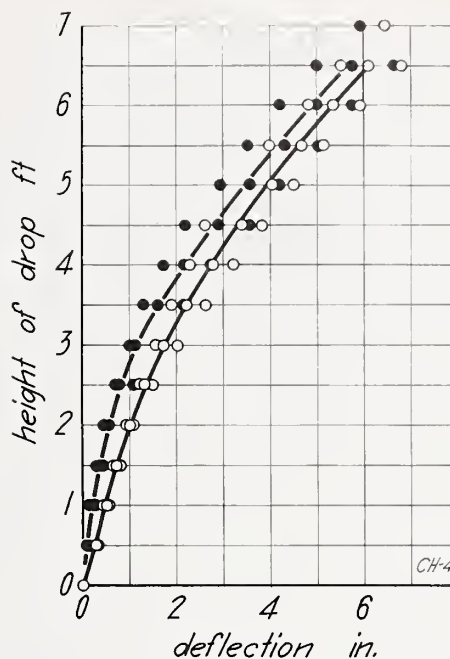
FIGURE 18.—Impact load on wall CH, load applied to outside face.

Height of drop-deflection (open circles) and height of drop set (solid circles) results for specimens CH-14, 15, and 16 on the span 7 ft 6 in.

The impact loads were applied to the center of the outside face of specimens *I4*, *I5*, and *I6*, the sandbag striking at a vertical and a horizontal joint. The effects of the impact load on specimens *I4*, *I5*, and *I6* are shown in table 7.

Description of effects	Height of drop for specimens		
	<i>I4</i>	<i>I5</i>	<i>I6</i>
First crack along base of ribs of from one to four units.	ft 3.0	ft 2.5	ft 2.5
Failure of specimen by crushing at the transverse joint at midspan and further cracking of units.	3.5	4.0	4.5
All units cracked.	5.5	5.5	7.0
Buckling of either one or two outer bonding plates.	6.5	6.5	7.0
Rupture of central bonding plate near midspan.	8.5	9.0	10.0
Maximum height of drop; under load, specimen came in contact with floor; deflection about 2 ft.	9.0	9.0	≈10.0

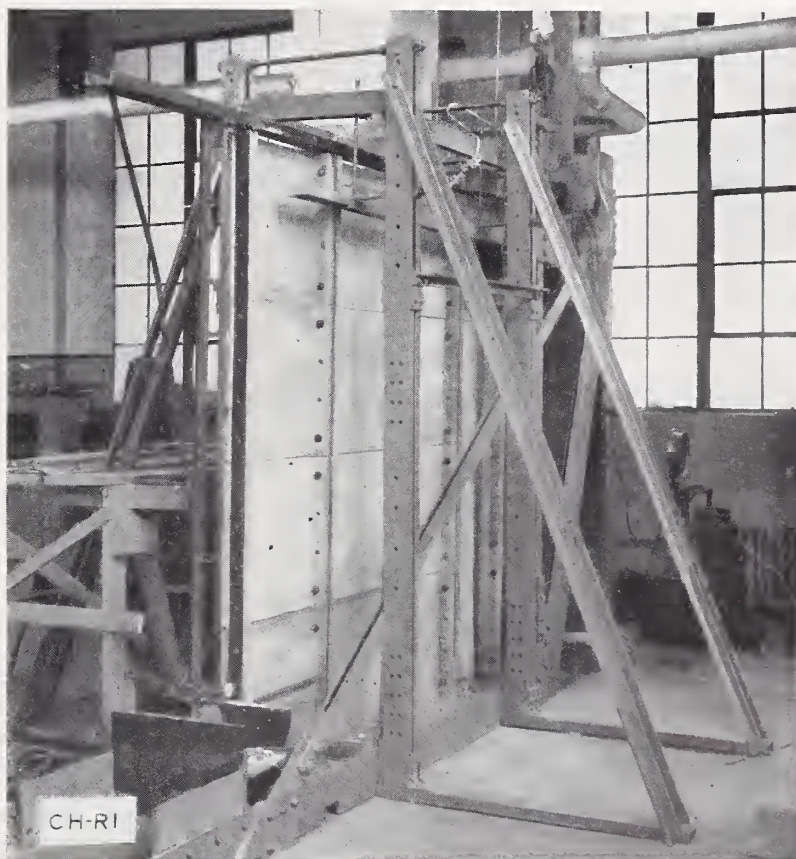
FIGURE 19.—Wall specimen CH-R1 under racking load.

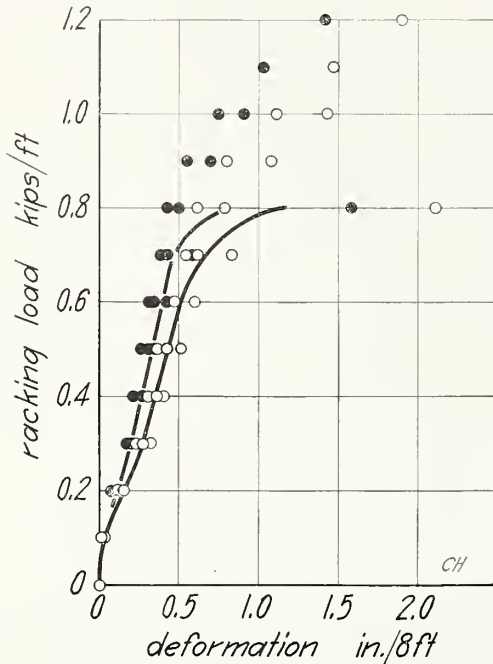
FIGURE 20.—Racking load on wall CH.

Load-deformation (open circles) and load-set (solid circles) results for specimens *CH-R1*, *R2*, and *R3*. The loads are in kips per foot of actual width of specimen.

In specimen *R1* under a load of 0.30 kip/ft the unit in the top course adjacent to the loaded unit cracked longitudinally (vertically). A similar crack in the corresponding unit occurred in specimen *R2* when the load was 0.24

kip/ft and in specimen *R3* when the load was 0.23 kip/ft. In each of the specimens more units cracked as the load was increased. Most of the cracks were at the base of the flanges. All of the units in specimen *R1* were cracked when the load was 0.90 kip/ft and in specimen *R2* when the load was 0.80 kip/ft. Under the maximum load the units in each of the specimens crushed and cracked at the base of the flanges and the bonding plates bent.
